## BRE Global Test Report

**Fire resistance test in accordance with EN 1365-2:2014 on a loadbearing floor, with two layers of Gyproc Fireline on the exposed face, suspended using an Oscar Iso-mount Type 1 system.**

**Report Number:** P112840-1000 Issue 1

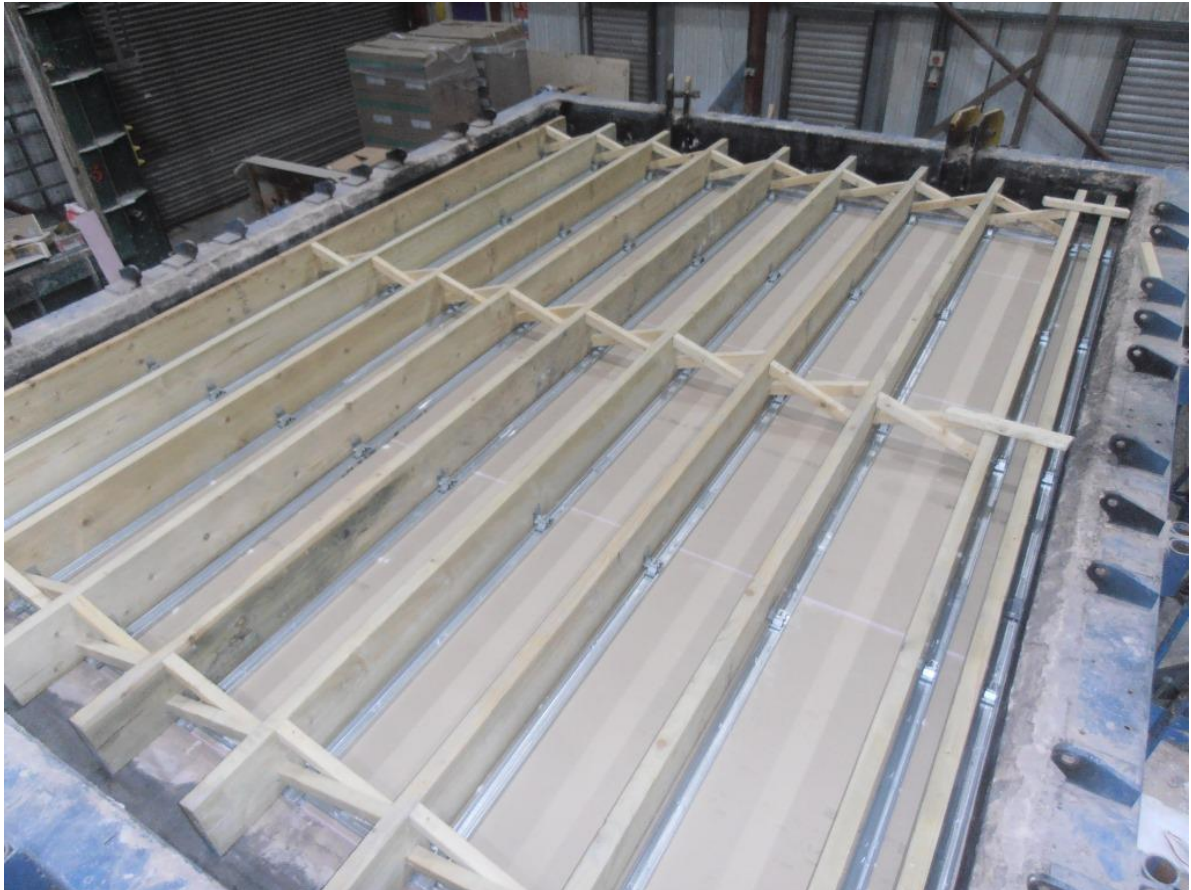
**Floor during construction.**

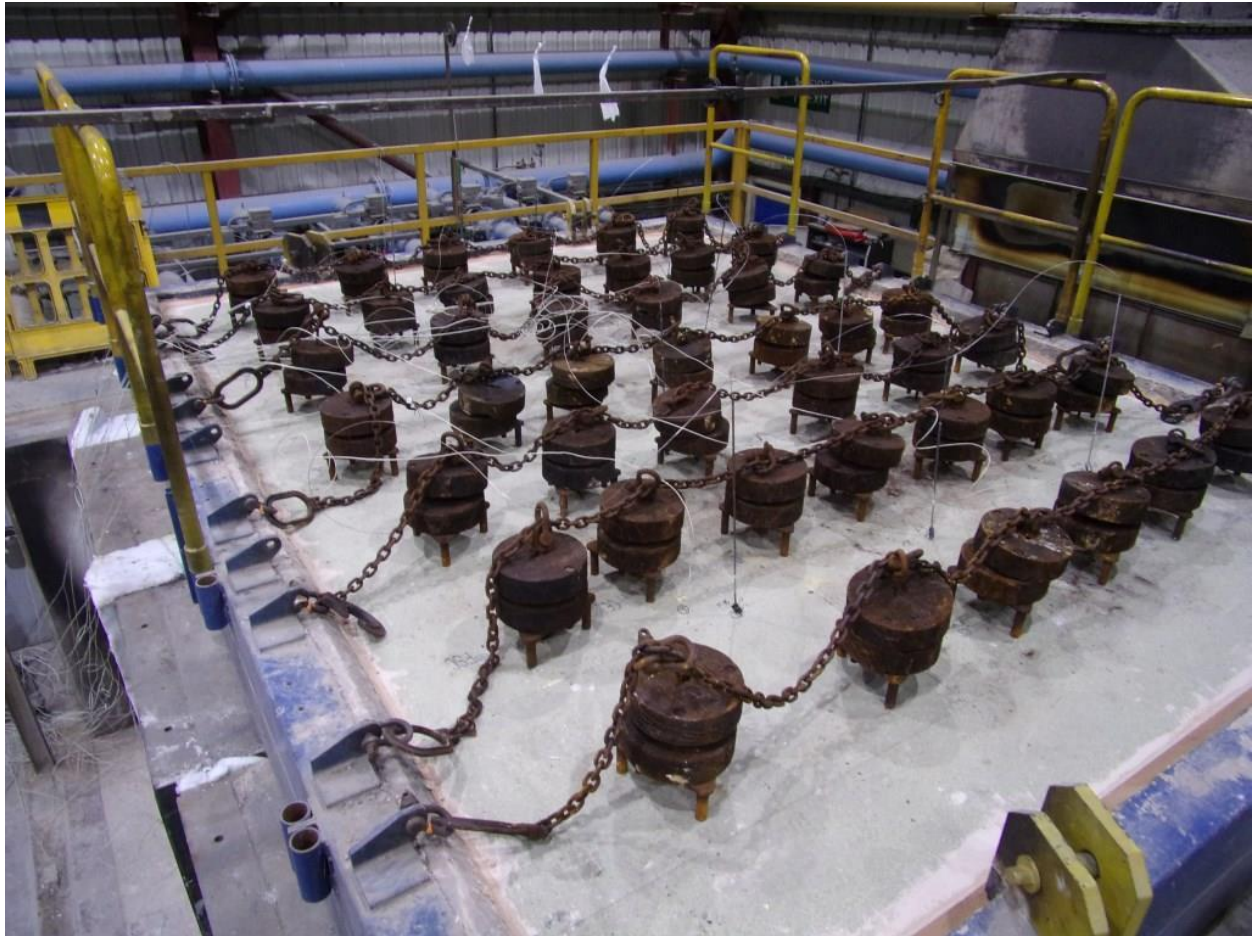
**Unexposed face before test.**

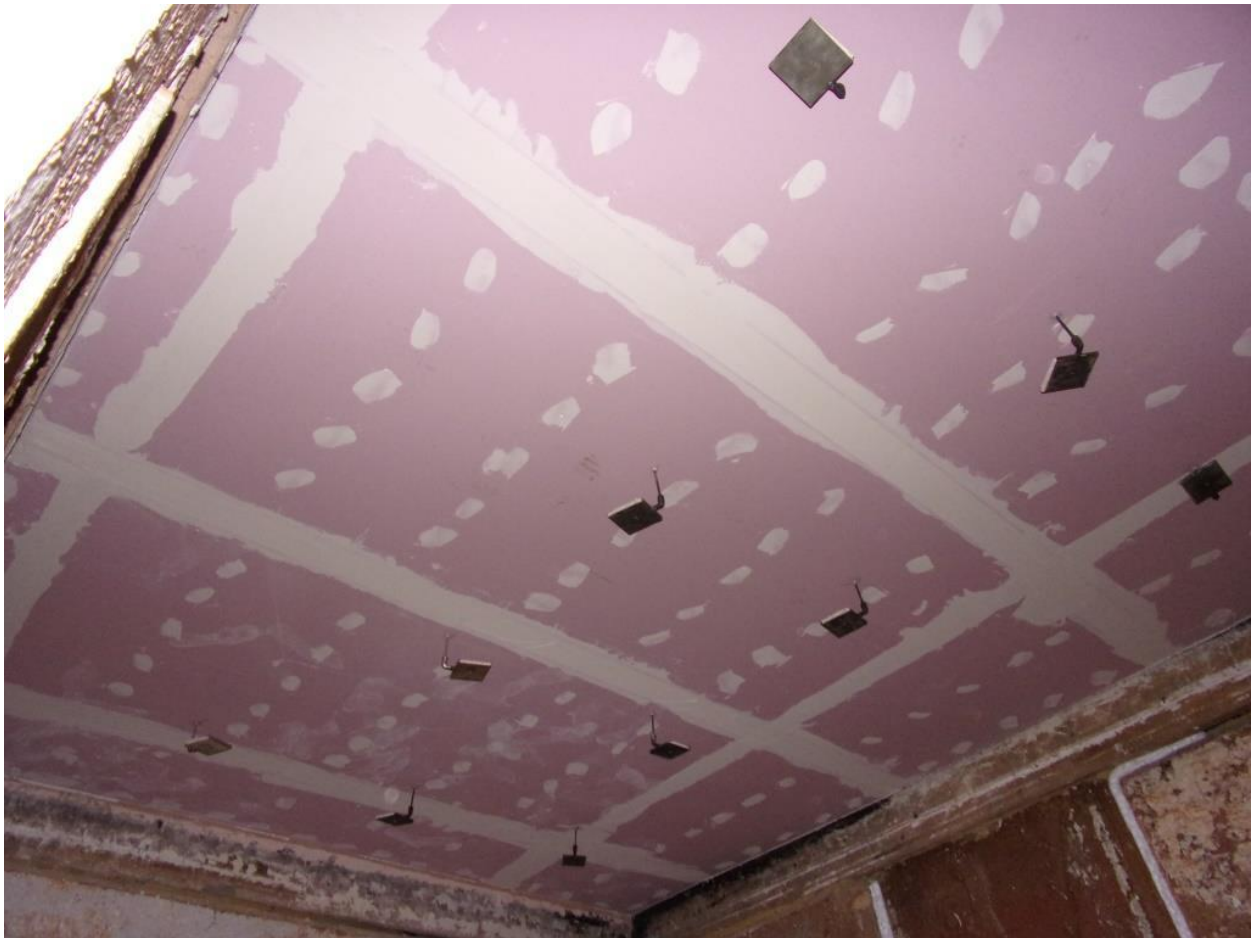
**Exposed face of floor before test.**
